# RECALL ACTION

Recall Action  
Number: P019

<b>Subject:</b>  <b>Park Brake Oil Contamination</b>	Publication No.:	P019
	Model:	Defender
	Model Year:	2007-2008
	Build Date:	7 <sup>th</sup> June 2007 – 13 <sup>th</sup> February 2008
	VIN Range:	LD066843 – LD068528 (CKD) LD740135 – LD757662
	Date of Issue:	04 December 2009

## RE: Park Brake Oil Contamination

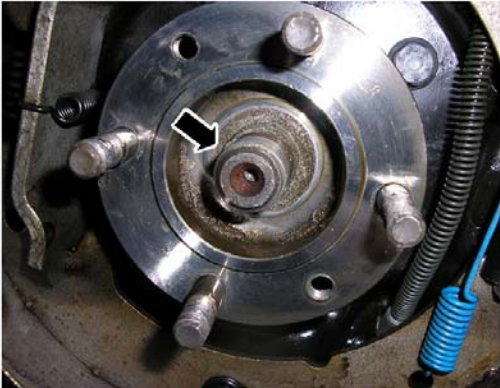
In all the above cases oil was identified to be leaking between the transfer output shaft and the drive hub due to damage of the felt washer which is designed to seal the joint. Once oil leaks out of the centre of the drive flange it tracks down into the park brake drum and can lead to contamination of the park brake shoes which can render the park brake ineffective.

Oil leaks past the felt sealing washer due to damage to the washer that occurs during the transfer case assembly process. The felt washer is subjected to a shear force during the tightening process of the output shaft flange retaining nut and washer. The shear force rips the top surface of the felt washer which becomes trapped between the drive flange, the washer and nut. The recess in which the rear output shaft felt washer sits does not accommodate the full thickness of the felt washer.

<p>M417584</p>
		Fig. 3
7	<p>Remove and discard felt washer (see Fig. 4).</p>

<p>M701239</p>
		Fig. 4
	<b>Installation</b>	
8	<p><b>NOTE: The brake shoe springs and dished washer are re-usable provided they are serviceable.</b></p> <p>If contaminated with oil, install new parking brake shoes (see Global Technical Reference GTR Workshop Manual, section: 206-05).</p>	
9	Install a new felt washer.
