TDi300 EDC Cold Starting Fix (temporary cure)

This details a temporary fix to my TDi300 1997 EDC model which was suffering from poor cold starting.

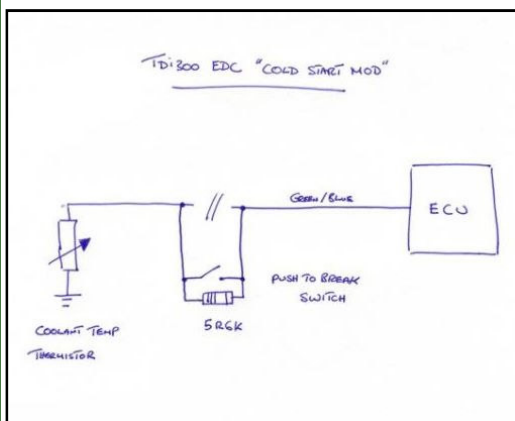
This is the circuit:

The 5.6K resistor is soldered across the two contacts of the switch in parallel with the two wires. In normal operation, this results in the circuit current going across the internal switch contacts and not via the resistor and thus is not affecting the feed to the ECU. When operated, the push to break opens the contacts and the circuit current goes through the resistor to the ECU, in series with the existing resistance of the coolant sensor.

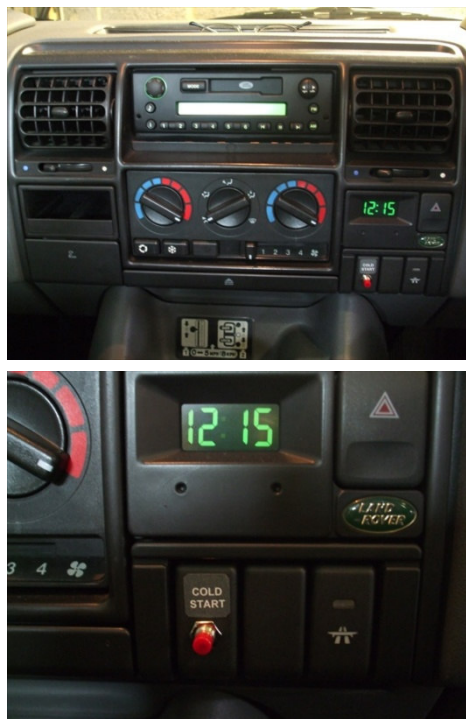
This is the finished job:

I spliced into the GREEN/BLUE wire feeding the ECU under the drivers side dash. It is one of many wires in a thick loom, covered in a plastic protective shield that goes to the ECU by the drivers foot well.

I cut the wire and soldered to each cut off, the twin wire and ran this up to behind the dash where I fitted the switch. The current/voltages involved are tiny so you don't need thick wire.
