Front Axle Driveshaft - Oil Leak		30/10/96 NRR/54/03/96/EN
MODEL New Range Rover	AFFECTED VEHICLES LP 348603 Onwards LH LJ LD

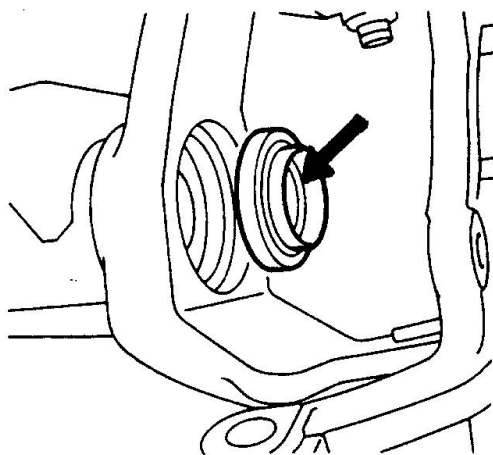
ILLUSTRATION

In the event of an oil leak becoming evident from the front driveshaft seal around the yolk area, a new driveshaft seal has been introduced.

Upon customer complaint of an oil leak around the driveshaft area, the new revised seal should be fitted, together with the brake caliper bolts and hub assembly bolts as detailed in the parts section.

FTC 4822 replaces FTC 3452 driveshaft seal

Note: New service tool No LRT-54-012 should be used in conjunction with the driveshaft seal.
