TECHNICAL SERVICE BULLETIN

reissue No.LTB00406v2/2012

Subject/Concern:	Heating Ventilation Air Conditioning Evaporator (HVAC) Temperature Reading Inaccurate - Evaporator Freezes		
Model:			
Defender (LD)	Year: 2007-2012 VIN Range: 7A732615- CA414266

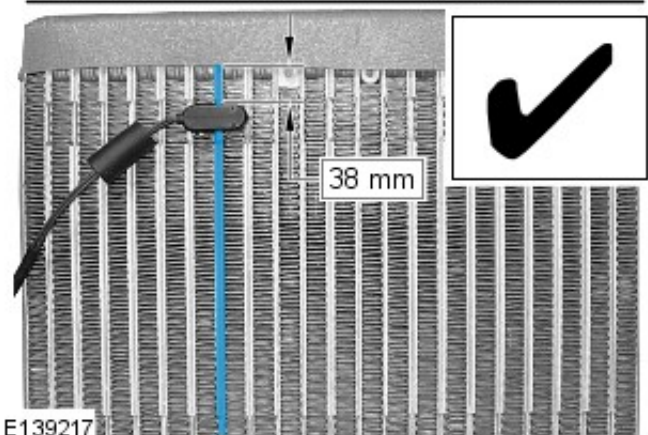
E139217

See graphic EI39217 for the new type of the HVAC evaporator temperature sensor and the correct position for it to be fitted.

Install a new HVAC evaporator temperature sensor.
