# HOMWORKSHOP

Defender 300 Tdi

## Replacing a brake servo

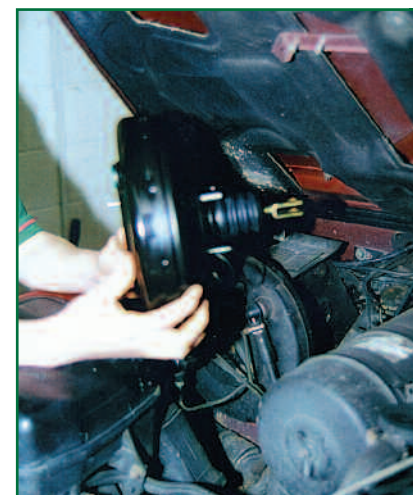
Always check physically that it is the right part before starting work; parts numbers on boxes are not always correct!

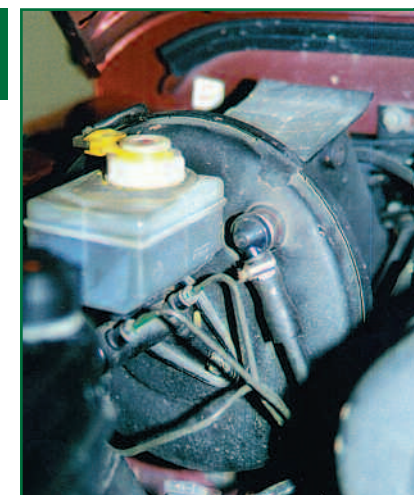
Disconnect the electrical supply lead for the low fluid-level warning light from the top of the brake fluid reservoir

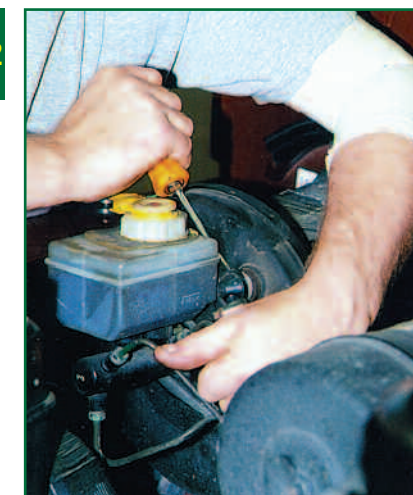
Using a screwdriver, carefully prise out the plastic connector for the vacuum supply hose from the servo unit

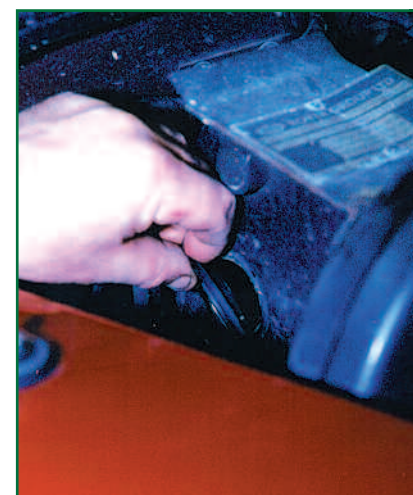
On each side of the pedal box is a blanking grommet; both of these need to be carefully prised out

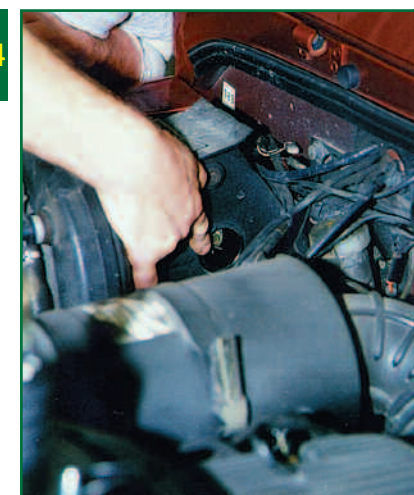
With the grommets removed, the split pin and clevis pin holding the servo push rod to the brake pedal are exposed

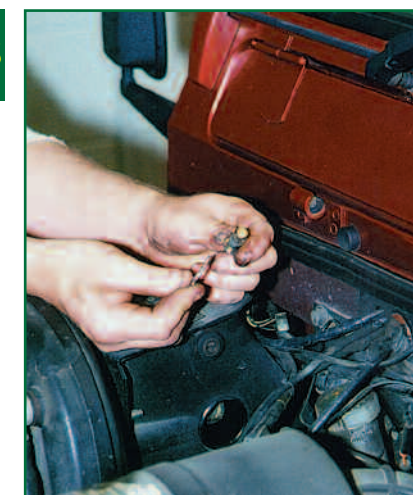
The split pin must be removed to allow the clevis pin to be withdrawn; it's best to use thin long-nose pliers

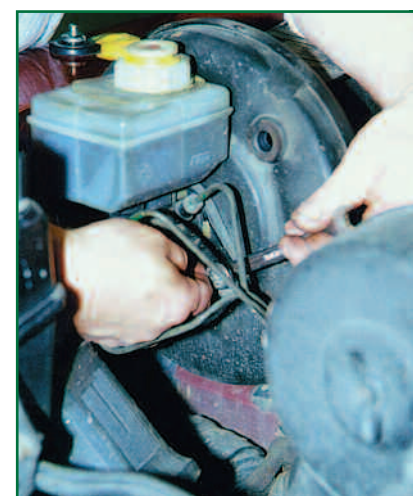
Next step is to undo the two nuts that secure the brake master cylinder to the servo unit itself

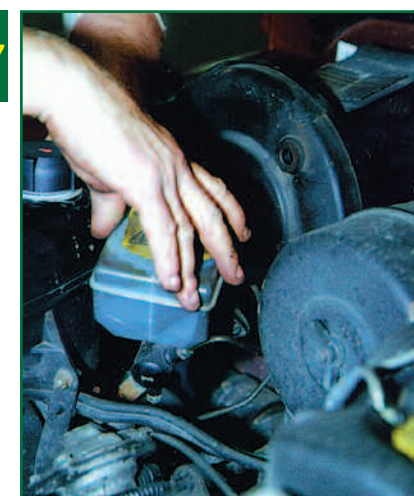
There is no need to undo the brake pipes; the master cylinder can be pulled clear of the servo assembly

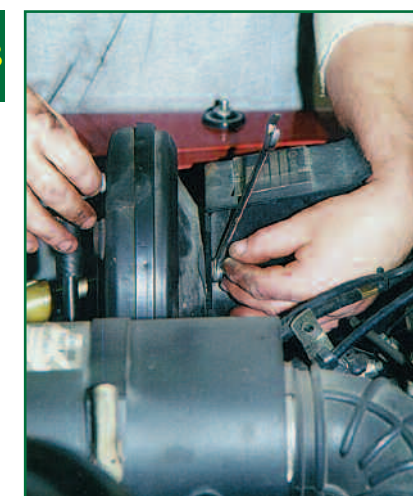
Next remove the four nuts at the back of the servo unit that secure it to the pedal box; accessibility isn't bad

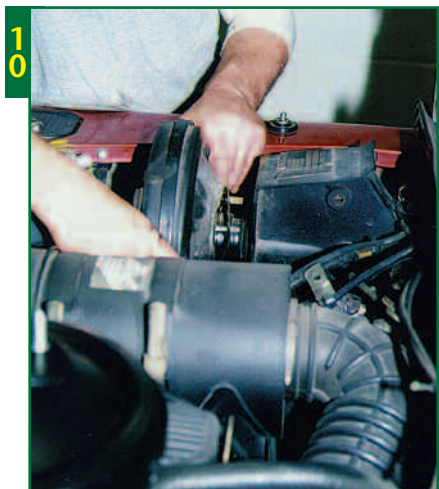
**10** Carefully pull the servo unit away from the pedal box assembly so as not to damage the sealing gasket

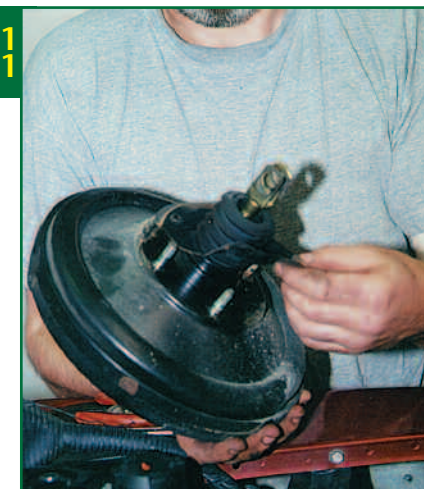
**11** With the servo now free from the pedal box, carefully remove the rubber gasket from the four retaining bolts

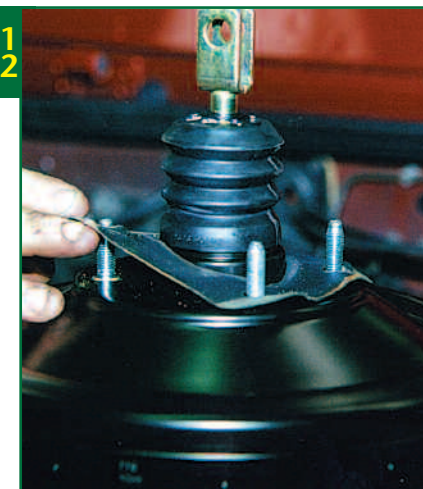
**12** You will need to refit the old gasket to the new servo; a replacement gasket is not supplied with it

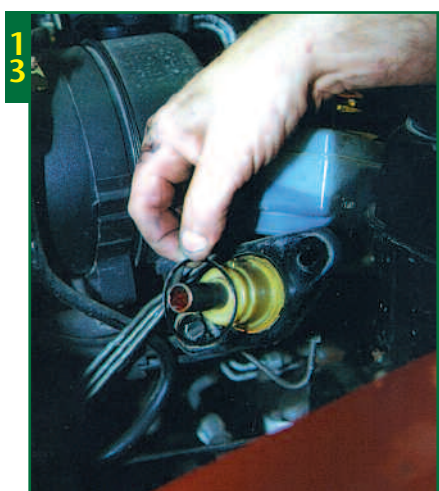
**13** An O-ring prevents water getting into the master cylinder; take this off the old servo and refit to the shaft

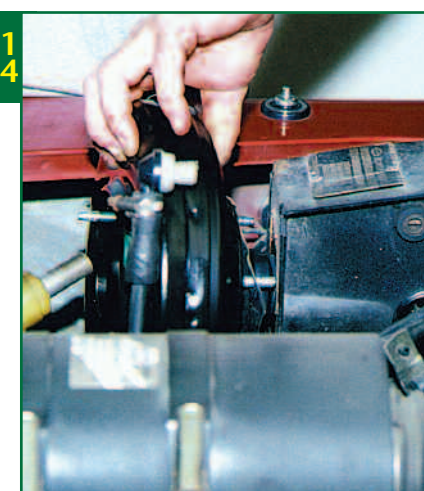
**14** The new servo unit can be fitted to the pedal box assembly, but don't bolt it up yet, to allow for movement

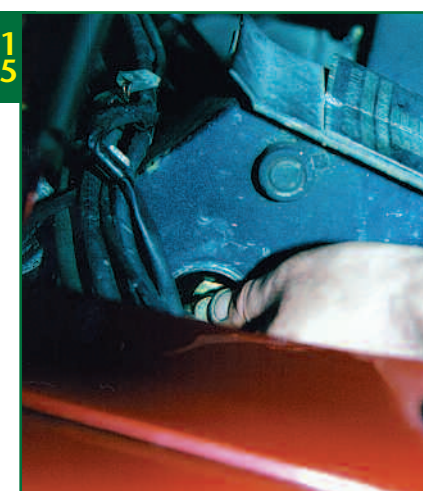
**15** Re-fit the clevis pin, holding the servo push rod to the brake pedal; a bit of movement makes alignment easier

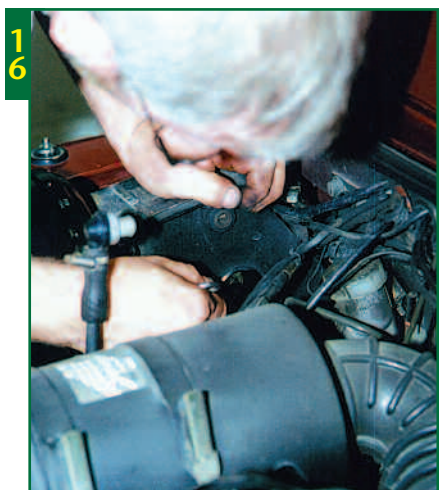
**16** The split pin needs to be re-fitted through the clevis pin. This is difficult! Use thin long-nose pliers or industrial tweezers

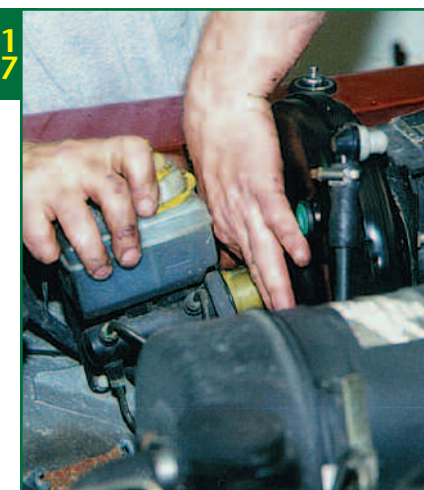
**17** Now tighten the retaining bolts, and re-fit the master cylinder. Ensure the plunger is correctly fitted to the shaft

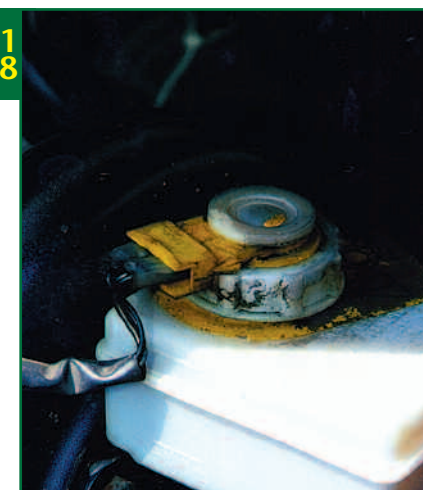
**18** Finally re-fit the vacuum hose and electrical lead (shown) and check that the brake pipes are not rubbing on each other. ■
