## Defender models

# Replacing a Power Steering Box

So our main *Home Workshop* feature this month shows you how to replace the PAS box on a Defender. We watched and photographed the operation being done on a 1994 200

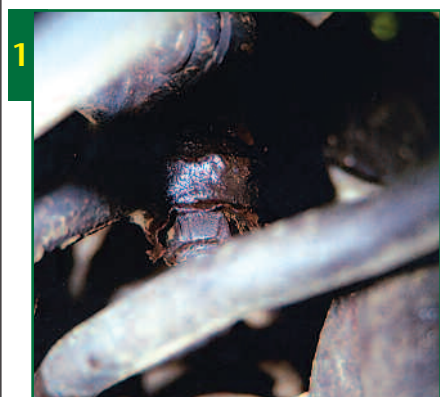
**Warning signs:** power steering fluid seen leaking from the box, dripping down the sector shaft or drop arm

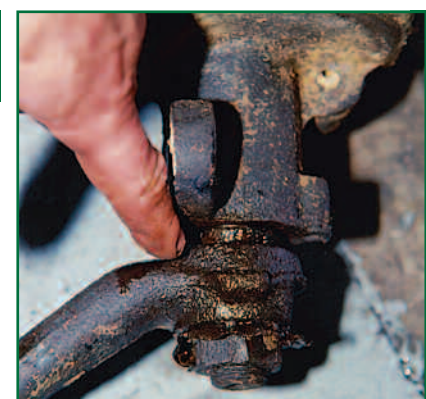
**With the box out,** the leak down the sector shaft past the seal and back-up seal can be clearly seen
