TECHNICAL SERVICE BULLETIN

reissue No.LTB00406v2/2012

Subject/Concern:	Heating Ventilation Air Conditioning Evaporator (HVAC) Temperature Reading Inaccurate - Evaporator Freezes		
Model:			
Defender (LD)	Year: 2007-2012 VIN Range: 7A732615- CA414266

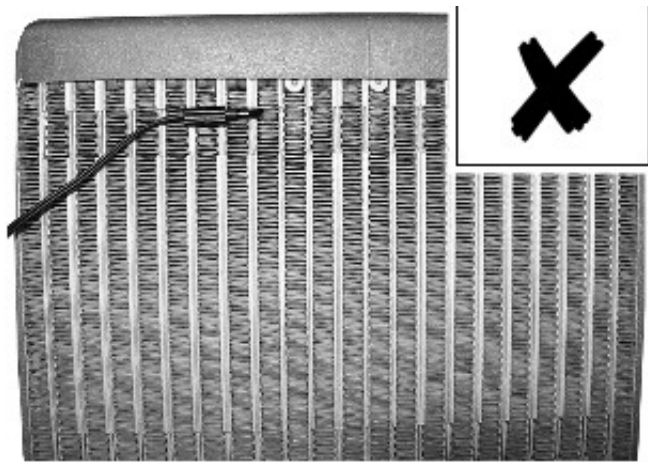
Summary
Customers may report that the temperature gauge reading goes from hot to cold and cold to hot very quickly, also that the air conditioning does not get cold. Dealers may also notice that the HVAC Evaporator & pipes have frozen.
This version has been issued to add an End VIN to the VIN Range.
Cause: Evaporator Temperature Sensor (De-icing Switch) is faulty. Suggested Customer Concern Code 42.
Action: Should a customer express concern, follow the Service Instruction outlined below.

See graphic EI39217 for the new type of the HVAC evaporator temperature sensor and the correct position for it to be fitted.

Install a new HVAC evaporator temperature sensor.
